# Manhole Inspection Summary

Manhole # S43I\_\_038MH

Insp Date: **4/29/08 2:04 PM**

**Location** Address: **301 s broadway**

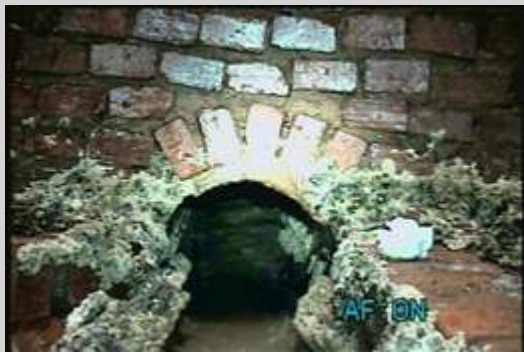
12 O'Clock Outflow

12 in. Circular Gravity Sewer  
Pipe Out @ 12 O'Clock

Pipe Material: **Clay** ☐ Pipe Lined

Invert Depth: **15.66** (ft.) Flow Characteristics: **Turbulent**

Deposits: ☒ None ☐ Mud ☐ Sludge ☐ Debris ☐ Grease

Infiltration: **None** Pipe Seal Cond: **Unknown**

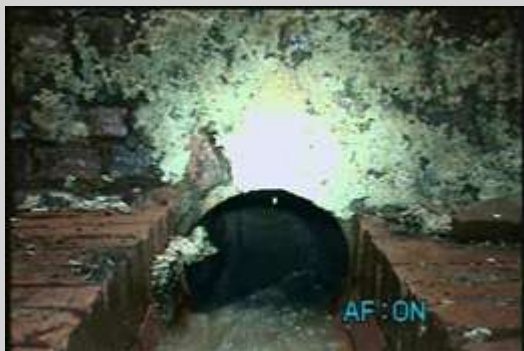
6 O'Clock Inflow

10 in. Circular Gravity Sewer  
Pipe In @ 6 O'Clock

Pipe Material: **Clay** ☐ Pipe Lined

Invert Depth: **15.58** (ft.) Flow Characteristics: **Turbulent**

Deposits: ☒ None ☐ Mud ☐ Sludge ☐ Debris ☐ Grease

Infiltration: **None** Pipe Seal Cond: **Unknown**

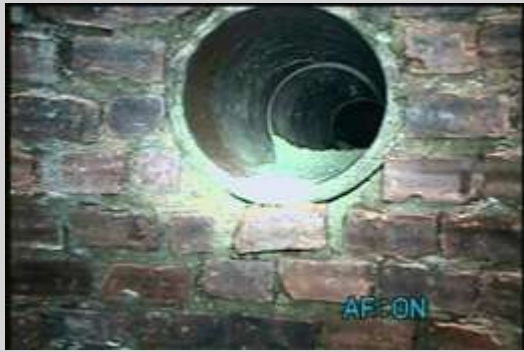
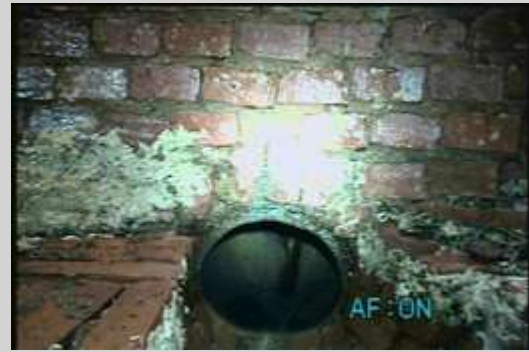
9 O'Clock Inflow

8 in. Circular Gravity Sewer

Pipe In @ 9 O'Clock

Drop In @ 9 O'Clock

Pipe Material: **Clay** ☐ Pipe Lined

Infiltration: **None** Pipe Seal Cond: **Unknown**

Drop Condition: **Open**
